Sun Coast Marine
Surveying and Consulting

Marine Survey Report For Sample Survey
"1997 Tiara 4000 Express"

18-315 1997 Tiara 4000 Express

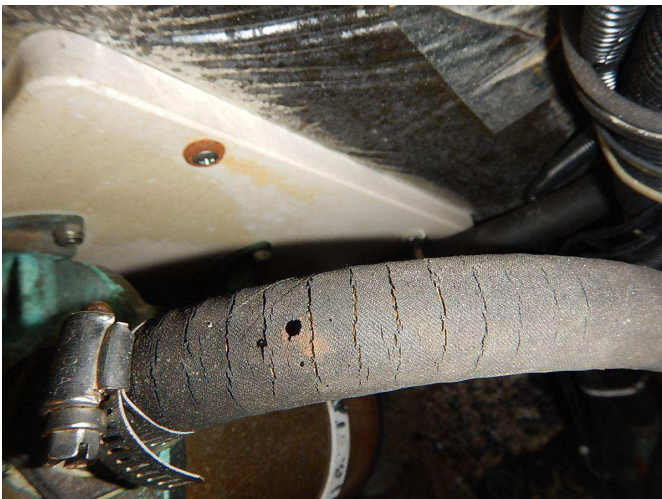
**FINDING A-2** SEA VALVES/SEA COCK TYPE

The generator raw water intake hose going to the strainer is wasted.

Replace wasted hose.

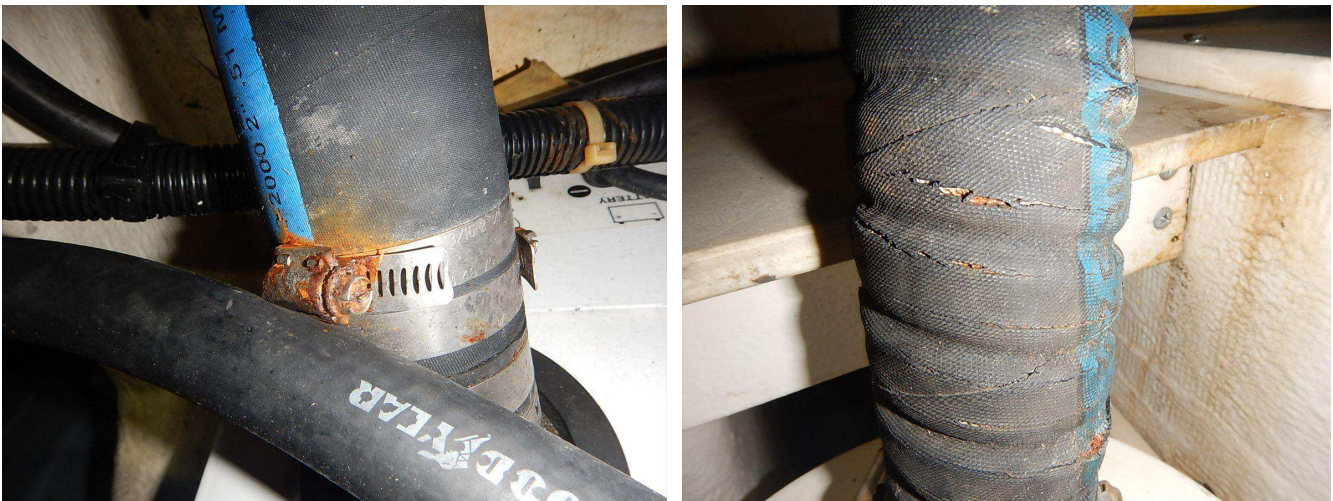
Exhaust hose leaving the muffler to overboard discharge is wasted and corroded hose clamps have corrosion.

Replace any corroded hose clamp and wasted exhaust hose.

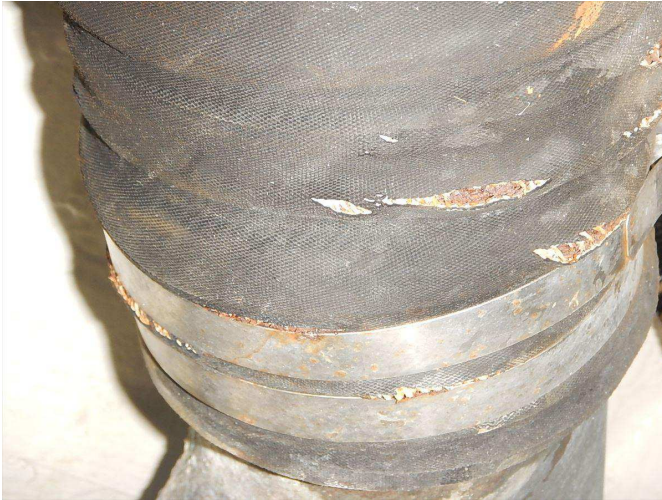
FINDING A-5 ENGINE(S)

Starboard side overboard exhaust discharge hose is wasted.

Replace exhaust discharge hose.

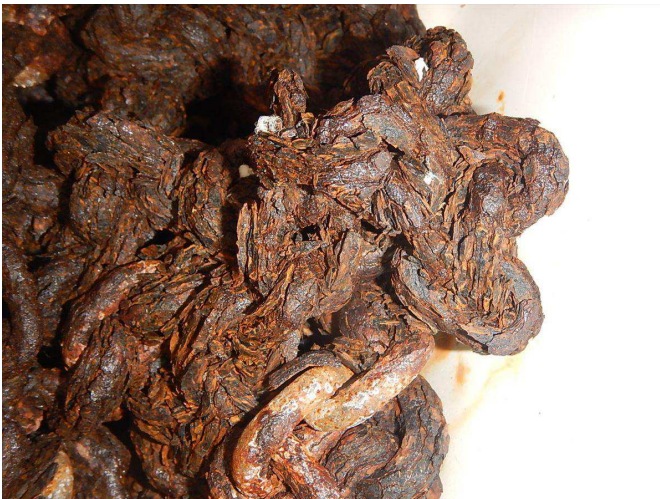
The chain appeared to be so heavily corroded that unsure if usable.

Replace anchor chain.

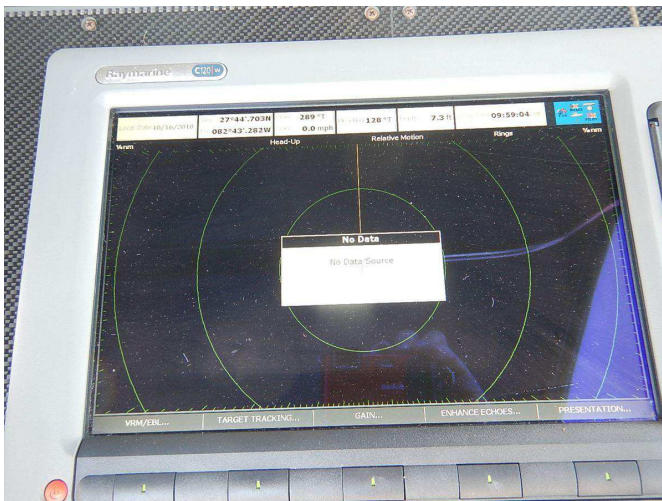
FINDING B-3 HELM STATION

The vessel radar was not operational and the chart plotter reads no data source.

Investigate radar system further and take action to make operational.

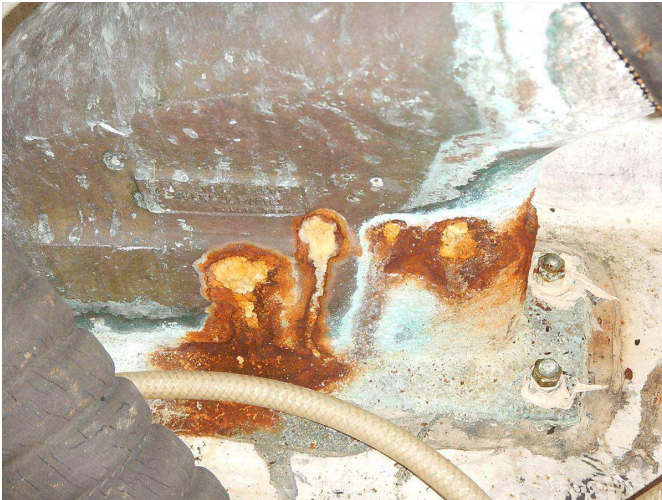
The port underwater exhaust hose fitting shows excessive corrosion and galvanic corrosion. No evidence the fitting is bonded.

Recommend replacing port underwater fitting.

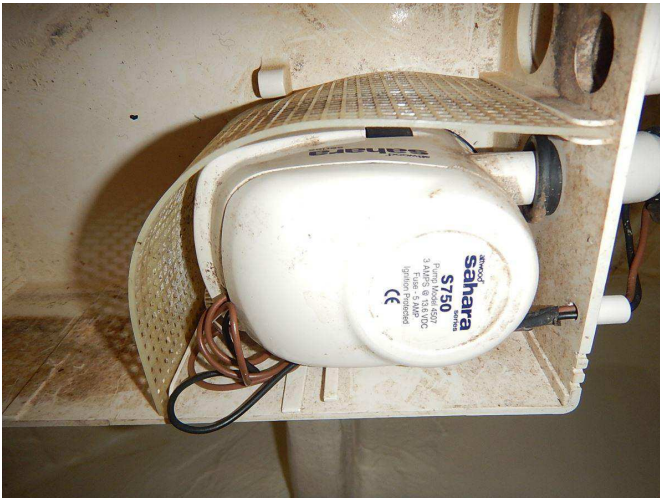
FINDING B-8 BILGE PUMPS

The forward Atwood bilge pump for the sump tank was not operational.

Repair or replace as required to make operational.

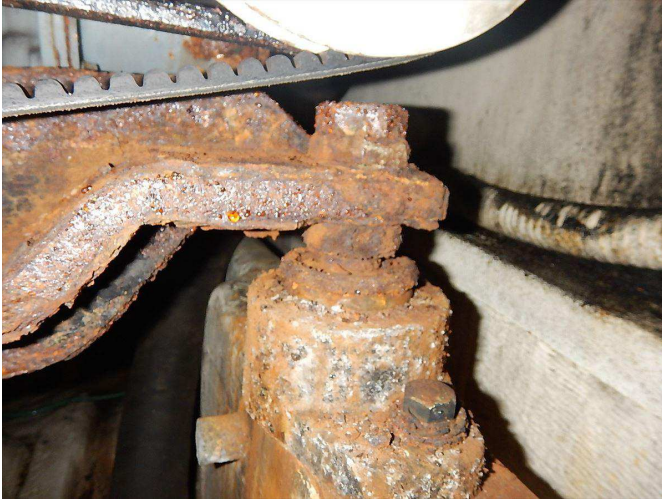
Some motor mounts are badly corroded.

Investigate further and take actions to replace if required.
