Sun Coast Marine
Surveying and Consulting

Marine Survey Report For Sample Survey
"1997 Tiara 4000 Express"

18-315 1997 Tiara 4000 Express

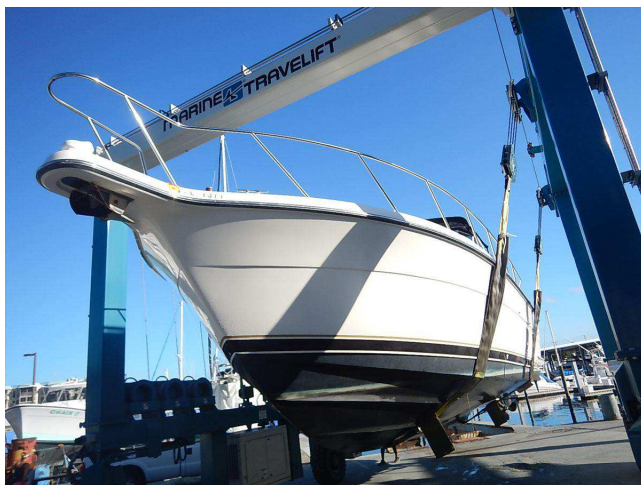
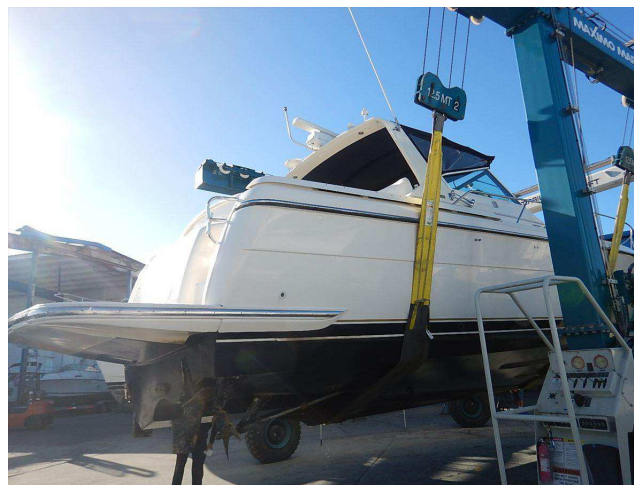
TRANSOM

Well secured, no cracks or defects sighted. Moisture readings were relatively Dry. No delamination when checked with a percussion hammer.

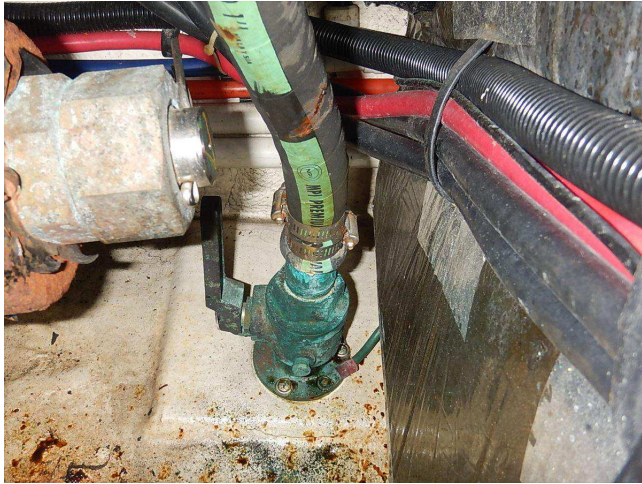
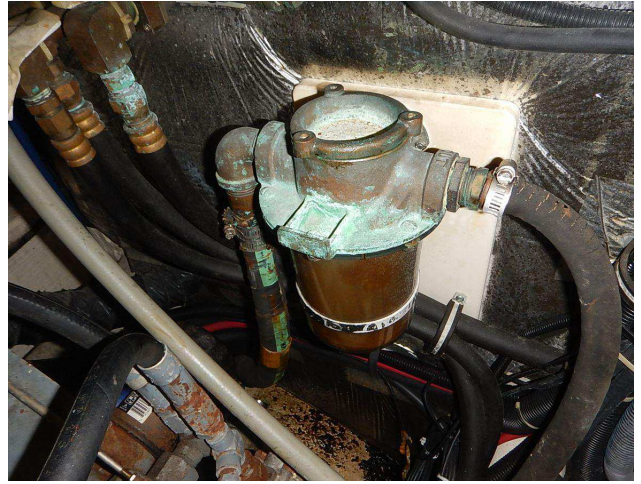
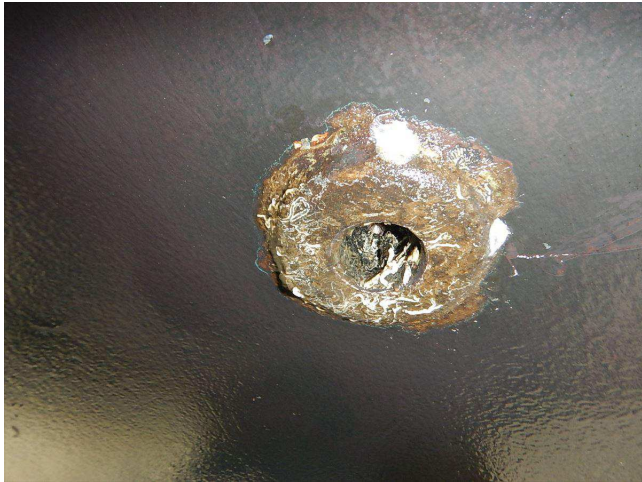
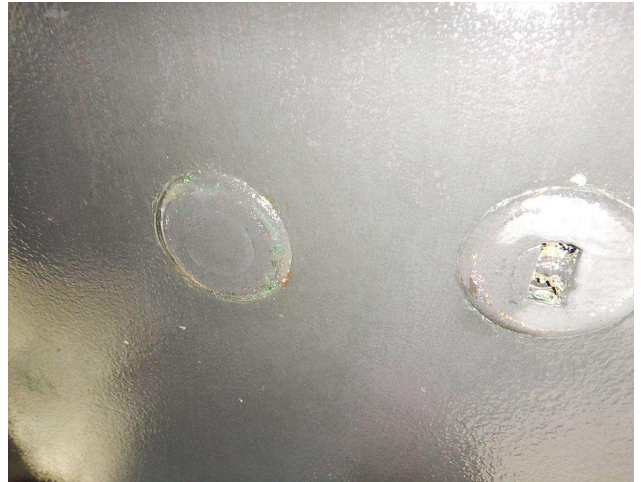
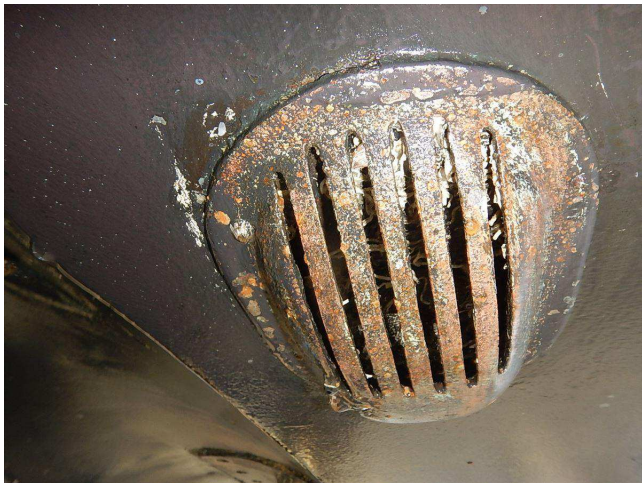
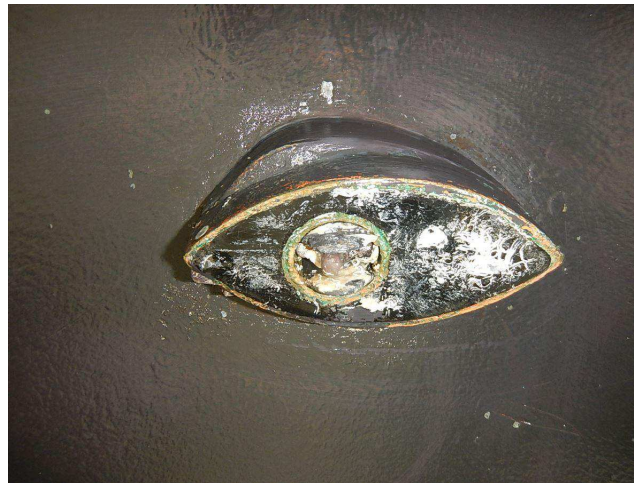
CONDITION & COMMENTS

In apparent serviceable condition except as noted in the Findings & Recommendations.

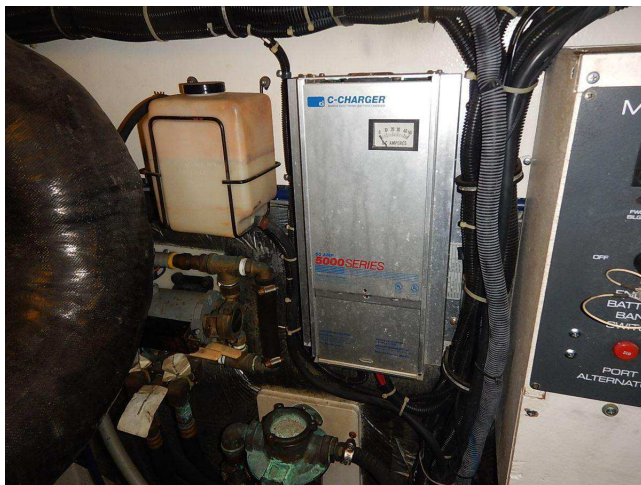
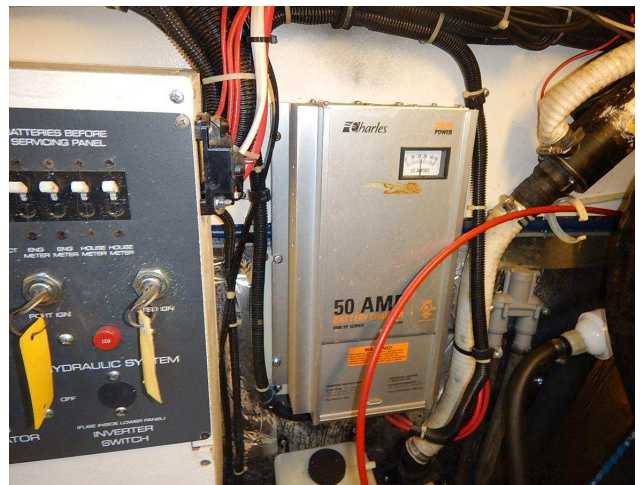
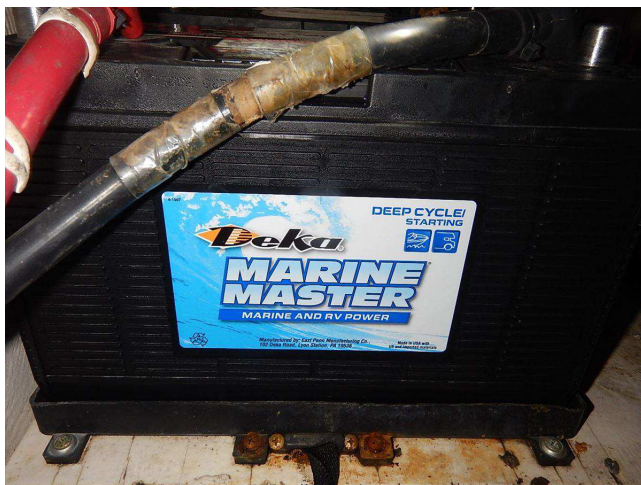
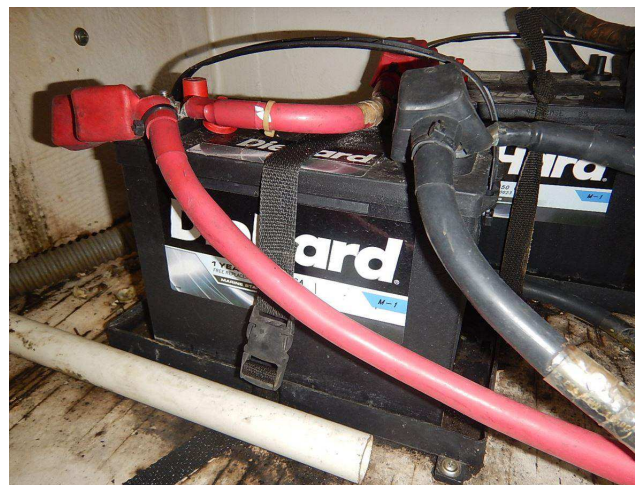
DIRECT CURRENT SYSTEM(S) TYPE

The vessel was equipped with a single 12Vdc system consisting of two battery banks. (4) Group 31 and (1) Group 24 12Vdc wet cell lead acid batteries are located in the engine compartment on the port and starboard outer sides and are in plastic battery trays and secure. The batteries provide power to all 12 V systems to include the engine start batteries, generator start battery, house electrical and anchor windlass. Two Guest rotary switches are located in the engine compartment. Where visible the vessel was wired with multi-stranded copper conductors with plastic-type insulation. Much of the wire did not appear to have been modified from its factory installation. Furthermore, were observed, no indications of overheating conductor insulation was observed. The terminals where splices could be seen consisted of ring terminals, terminal plugs, spade and blade terminals, fork terminals, common butt splices, and waterproof butt splices. Battery charging was accomplished by 12 Vdc unknown amperage alternators on each engine, the onboard generator and shore power by two Charles 5000 Series 50 Amp battery chargers that powered up. The main DC panel board is located on the starboard side wall of the main salon. All panels were clearly marked for voltage. Overcurrent protection of the system was provided by a variety of in-line fuses of different types, push-button thermal reset breakers and circuit breakers.

Check all battery dates prior to purchase to determine any batteries that are older than 3 years, It is recommended any battery over 3 years be replaced. Batteries are not load tested as a part of the survey and often battery dates are not visible. Verify this information prior to closing.

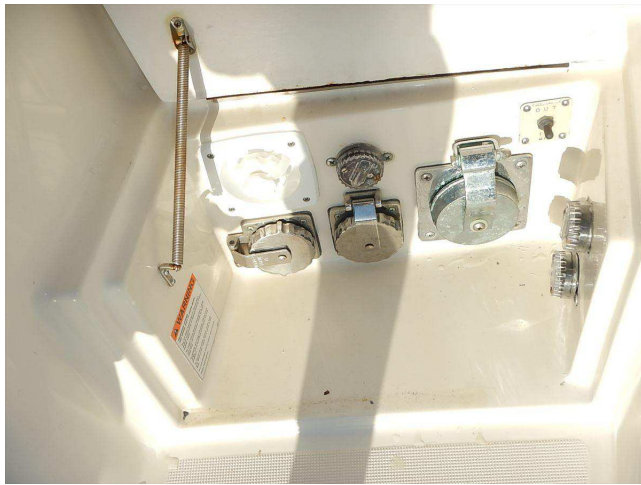
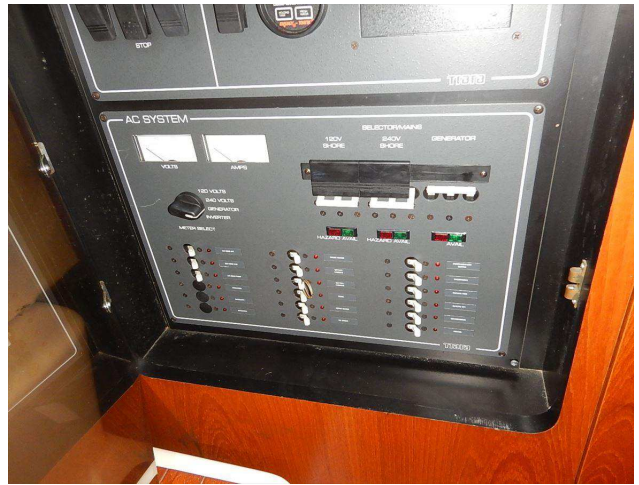
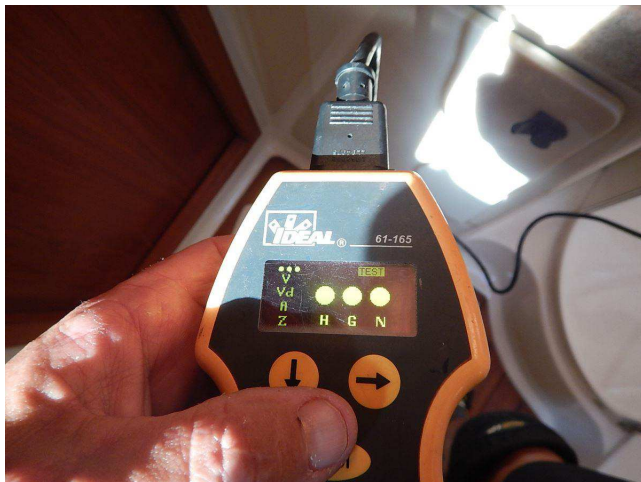
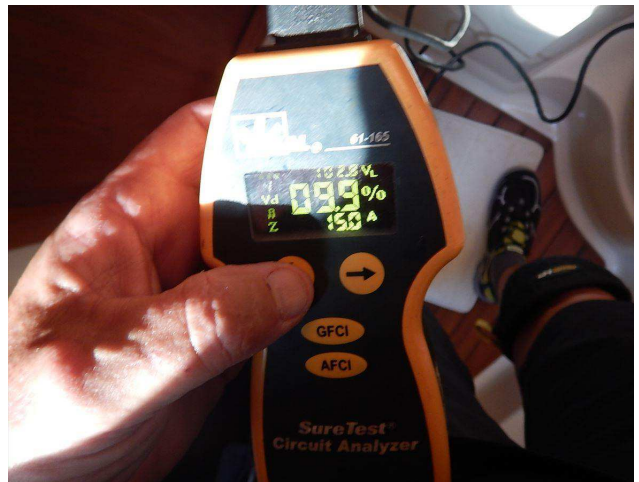
The vessel was equipped with one 240 VAc Glendinning50 amp single phase Ac system with power Cablemaster. The vessel shore power connections were located on the starboard transom. The operable main shore power circuit breaker is located at the AC distribution panel in the main salon. All breakers were operable and analog volt and amp gauges were installed at the power panel. Overcurrent protection was provided for with individual branch circuit breakers in addition to the main shore power circuit breaker installed on the panel board. An operable main circuit breaker was also installed at the generator, and the generator/shore power selector switch at the panelboard in the salon was an operable make or break type switch. Where accessible and visible, the shore powers system's consisted of multi-stranded copper conductors with plastic-type insulation, and the terminal's consisted of ringing terminals and butt slices. The system's wiring in so far as could be determined did not appear to be modified from its factory installation, and no indications of overheating of the visible portion's of the wiring insulation was found. The Ac panel board was fitted with reverse polarity indicators which were functioning. GFCI protected AC receptacles were installed in the vessel. The systems impedance, voltage drop, polarity and GFCI function were tested at each Ac receptacle with a Suretester device with shore power and generator supplied power and tested normal except as indicated in the Findings & Recommendations. As far as could be determined by general examination without making disassemblies, the system was found to be in apparently good working order.

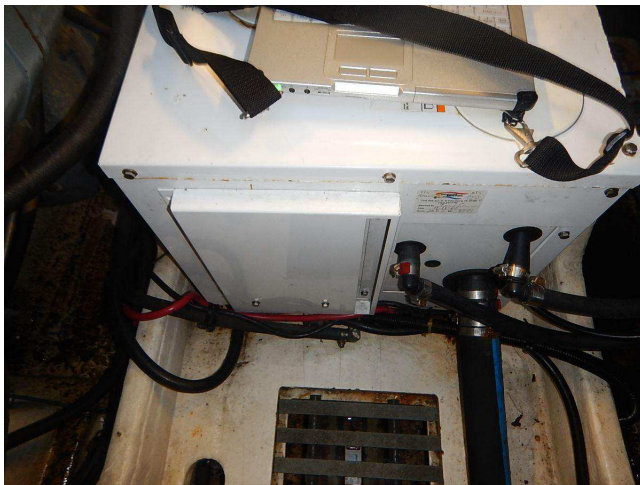
Located in the engine room is an Onan 7.5KW 4 cylinder diesel generator. The generator is a freshwater cooled unit, coolant levels were full. The oil level was full when checked. All hoses appeared to be serviceable. The generator started and functioned by holding a full load, all air conditioning units, stove burners, oven and microwave were powered on, the generator maintained voltage. See Findings & Recommendations.

FINDING A-4

FINDING C-5

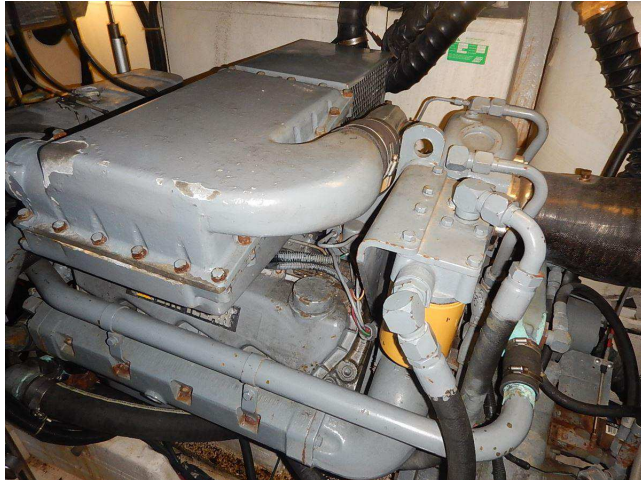
Two Caterpillar 3208TIA in-line six-cylinder diesel engines with raw water cooled closed loop cooling system and wet type of exhaust with 435 rated horsepower. The engines were secured to the vessels longitudinal main stringers made fast by stainless steel engine mount fasteners. No drip pads available, fluid and the debris fall into the bilge area beneath the engines. The engines cooling systems were equipped with engine mounted heat exchangers, engine mounted raw water cooling pumps, engine mounted closed system circulating pumps, remotely mounted closed system expansion bottles and pipe with reinforced hard wall marine water hoses secured with hose clamps, engine mounted OEM type cooling system hoses secured with hose clamps and metal piping. Bronze raw water strainers with site glass were incorporated into the raw water intake hoses, and the raw water was discharged to the exhaust at the mixing elbows. The exhaust systems were wet type with approved high-temperature silicon wet exhaust hose sections, common approved type wet exhaust hoses, metal exhaust tubing and discharged to the aft stern quarters through FRP exhaust tubing laminated into the hull. All sighted exhaust hose connections were made fast with double hose clamps per ABYC recommendations. All hoses appear to be in serviceable condition. Belt condition appears to be serviceable with no cracks or evidence of belt dust sighted. See Findings & Recommendations. The engines were inspected by EngineSurveyor.com who will issue a report under separate cover.

FINDING A-5

FINDING B-5

FINDING C-6

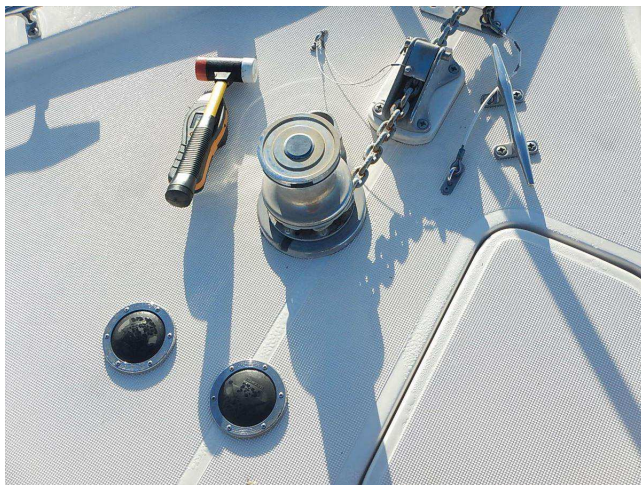
Primary: A galvanized steel 44lb Blue Star anchor is mounted at the anchor platform with an undetermined length of raw chain and considered serviceable other than noted in the Findings & Recommendations, showing excessive wear and wastage. See Findings & Recommendations.

Windlass: A Maxwell windlass is mounted on the platform. See Findings & Recommendations.

FINDING A-11

FINDING A-12

FINDING B-9

The chain appeared to be so heavily corroded that unsure if usable.

Replace anchor chain.
